# LANDSLIDES AND LINEAR INFRASTRUCTURE IN WEST-CENTRAL BRITISH COLUMBIA

Destructive landslides are common in west central British Columbia (BC). Landslides include debris flows and slides, earth flows and flowslides, rock falls, slides, and avalanches, and complex landslides involving both rock and soil. Pipelines, hydro transmission lines, roads and railways have all been impacted by these landslides, disrupting service to communities. We provide examples of the destructive landslides, their impacts, and the climatic conditions associated with the failures. We also consider future landsliding potential for west central BC under climate change scenarios.

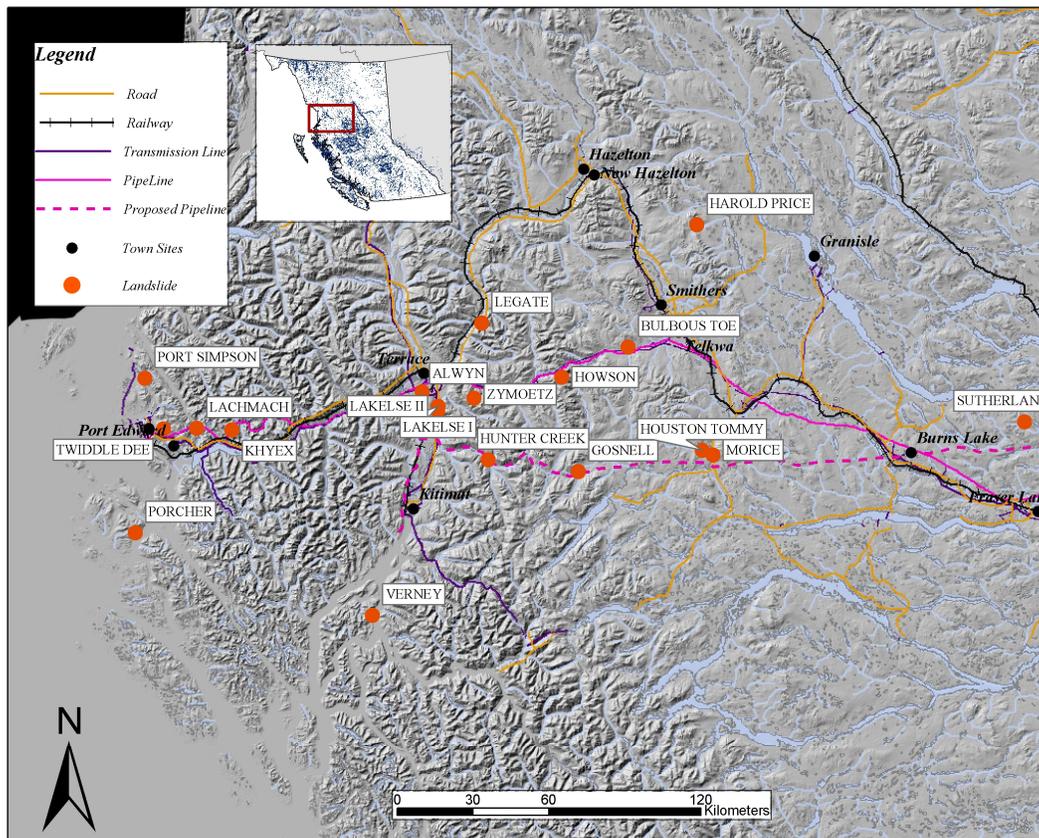
Figure 1. Landslides and linear infrastructure in west central BC. The landslides shown are described in the text and represent a small portion of actual landslides in the area.

West central British Columbia (BC) is a rugged, but sparsely populated portion of the province (Figure 1). Nevertheless the area hosts important transportation corridors, linking its communities and providing Canadian access to the Orient. Infrastructure includes roads, railways, hydro transmission lines, and hydrocarbon pipelines. The cities of Kitimat and Prince Rupert are important deep sea ports that are expected to undergo substantial growth to meet the needs of growing Asian economies. Recently, major oil pipelines have been proposed, connecting the North American network to a Pacific tidewater port at Kitimat.

are large rock slides, some of which transformed into debris avalanches and/or flows, debris flows, debris slides, earth flows in glacial lake sediments and in fine textured colluvium, and flowslides in sensitive glaciomarine sediments. The locations of the described landslides are shown in Figure 1.

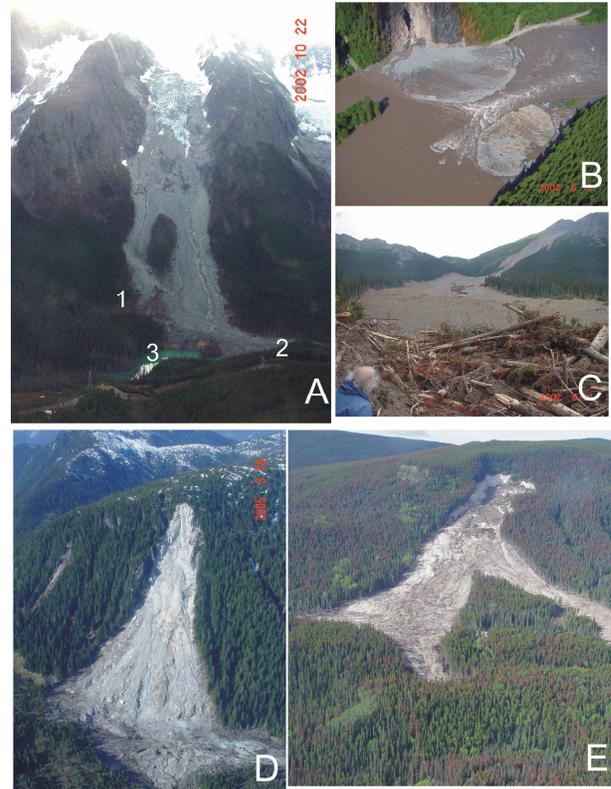
Figure 2. Large, long runout rock slides in west central BC. See Figure 1 for locations. (A) The 1999 Howson rock slide entrained till and colluvium, severing a natural gas pipeline (1). Note the hydro transmission line (2) and the landslide dammed lake (3). (B) The 2002 Zymoetz rock slide transformed into a channelized debris flow, dammed the Zymoetz River, flooded an important Forest Service Road for more than a year, and ruptured a pipeline. The landslide traveled 4 km. (C) The 2002 Harold Price rock slide transformed into a debris avalanche and then into a channelized debris flow, traveling more than 4 km. (D) the 2002 Verney rock slide on the outer coast traveled 630 m. (E) The 2005 Sutherland rock slide transformed into a debris avalanche and traveled 1.6 km.

The 1999 Howson rock slide (Figure 2a) occurred at 03:00 hours PDT on 11 September. The rock slide travelled 2.7 km, entraining till and colluvium. It ruptured the natural gas pipeline, and formed a lake. The initial rockslide involved  $0.9 \text{ M m}^3$  and the entrained volume is estimated to be  $1.5 \text{ M m}^3$  (Schwab et al 2003). The initial movement involved toppling and cliff collapse onto a glacier. The debris travelled over the glacier and entered a gully where it entrained soil and transformed into a debris flow.

On 8 June, 2002, a rock slide involving  $1.6 \text{ M m}^3$  transformed into a debris flow, damming the Zymoetz River, and severing a natural gas pipeline (Figure 2b; Schwab et al. 2003; Boulton et al. 2006). The landslide travelled 4.3 km. An estimated  $0.5 \text{ M m}^3$  of debris, including blocks up to 7 m in diameter, dammed the river, causing flooding 1.5 km upstream. Although the dam was overtopped almost immediately, it is still an obstruction to river flow. Access to a  $3000 \text{ km}^2$  basin was blocked for more than one year due to the flooding of a major Forest Service road.

Two other large rock slides occurred in west central BC in 2002, along with others elsewhere in the province (Geertsema et al. 2006a). The Harold Price and Verney landslides occurred near Smithers and southeast of Prince Rupert on the outer coast, respectively (Figure 1). The Harold Price landslide (Figure 2c) initiated in what appeared to be a rock glacier in a cirque basin sometime between 22 and 24 June. Interstitial ice was found in the main scarp. After travelling 1.3 km the rock slide transformed into a debris avalanche entraining till and colluvium. 2.2 km from the source the debris avalanche became channelized into a debris flow. The total travel distance of the landslide was 4 km. The volume is estimated to be  $1.6 \text{ M m}^3$ . The Verney landslide (Figure 2d) is less precisely dated (Geertsema et al. 2006a). It probably initiated as a rockfall. The landslide travelled 630 m over a

On July 13, 2005 a complex rock slide - debris avalanche occurred near Sutherland River, 40 km west of Fort St. James, British Columbia (Figure 2e). The landslide impact was powerful enough to leave a seismic signal at the Fort St James seismic station. The rapid landslide traveled 1.6 km and involved  $3\text{M m}^3$  of volcanic rock and soil. The landslide bifurcated in the runout zone. Pre-slide deformation was evident on aerial photographs and the slide site had been heavily impacted by mountain pine beetle.

and catastrophic failure (Holm *et al.*, 2003) such as at Howson Glacier (Figure 2a).

Alpine permafrost may be degrading under the present warmer climate, decreasing the stability of slopes (Harris *et al.*, 2001). Recent large rock avalanches in the European Alps have been attributed to the melting of mountain permafrost, and this phenomenon may also play a role in initiating landslides in northern British Columbia, as in the case of the Harold Price landslide (Figure 2c).

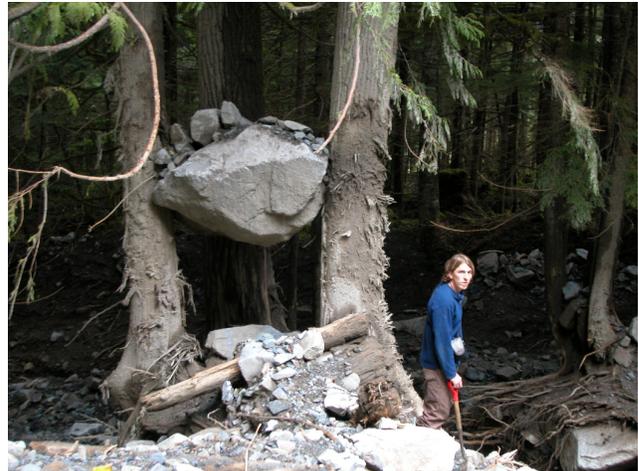
Figure 3. A debris flow at Legate Creek lodged this large boulder between two trees.

An example of a fan that is traversed by a major highway and subject to episodic debris flows (Figure 3) is near Legate Creek (Figure 1). Two debris flows closed the highway at separate times in July and August 2004 with volumes of 7,000 and 20,000  $\text{m}^3$ , respectively. On 28 May, 2007 a much larger debris flow crossed the highway, killing two people. An earlier debris flow in 1978 was also larger (Septer and Schwab 1995). Scars on trees record the 1978 event as well as an episode about 85 years ago.

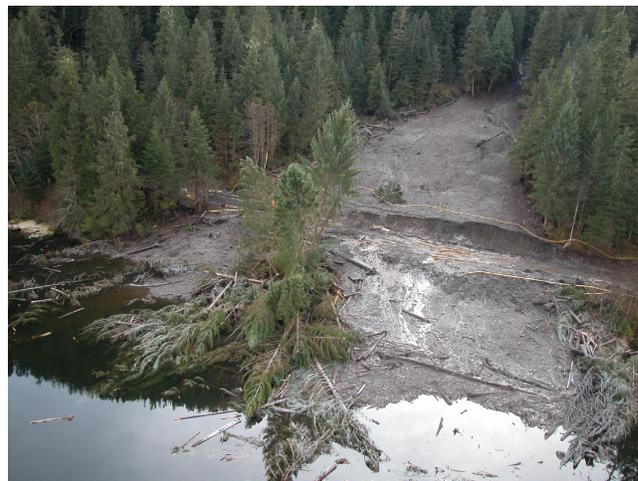
Figure 4. Recent shallow debris avalanche severed a gas pipeline and a road near Prince Rupert. Photo Tom Bond.

Shallow, rapid debris slides and avalanches occur throughout west central BC, but are particularly common on the coast in shallow soils draping steep bedrock (Figures 4 and 5). These landslides typically initiate during intense rainstorms, after certain antecedent conditions are met. The landslides have closed roads and severed hydro transmission lines repeatedly at Porcher Island and Port Simpson. In October 2002, an intense storm triggered more than 12 debris slides that took out the power to Port Simpson. Similar landslides removed power poles on Porcher Island in 1998, 2001, and 2005.

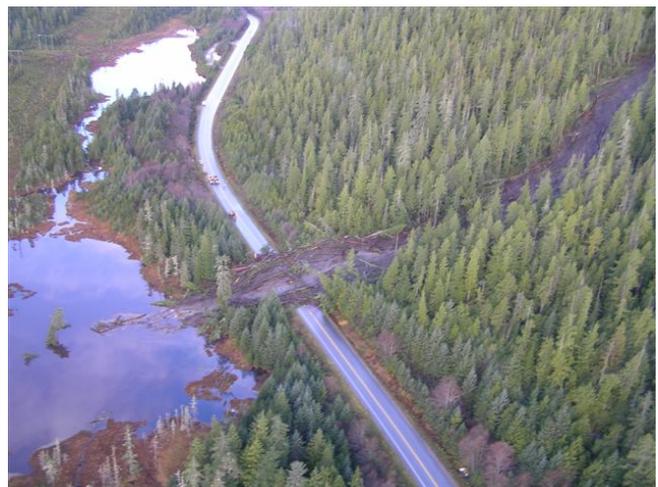
Figure 5. A debris avalanche across Highway 16, near Prince Rupert. Photo Tom Bond.

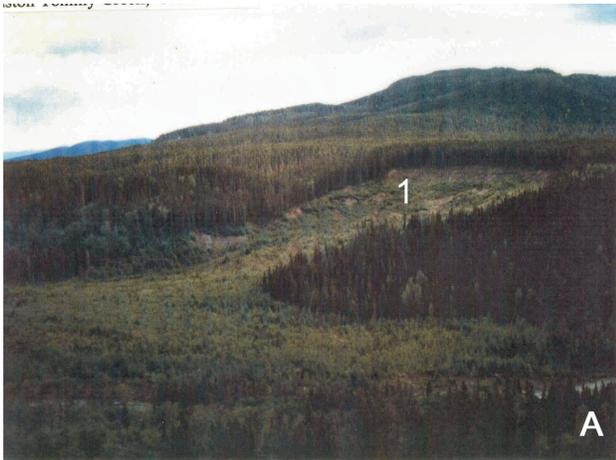
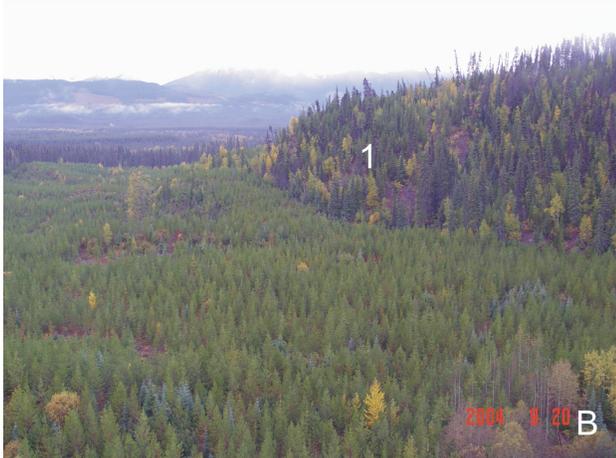
Figure 6. Earth flows in west central BC. (A) A rapid earth flow (1) at Houston Tommy Creek involved advance phase glaciolacustrine sediments. (B) An advancing lobe (1) of the Bulbous Toe near Telkwa involves fine textured colluvium. Note the leaning trees. This slow moving earth flow is traversed by a hydro transmission line. One of the towers requires periodic adjustment.

A series of large, rapid, low gradient earth flows near Houston involve areas of up to 100 ha. A 40 ha flow along Houston Tommy Creek, that occurred in the 1960's involves more than  $1.5 \text{ M m}^3$  of material (Figure 6a).

A large landslide, referred to informally as the Bulbous Toe, in the Telkwa River valley (Figure 6b) underwent rapid movement in prehistoric time (BC Forest Service, unpublished data). In the historic period a portion of the landslide continues to advance as a slow-moving earth flow. A major transmission line traverses the landslide, and adjustments are periodically required for one of the towers. About 30 cm/year of movement over the past 10 years has occurred along the tower. The colluvium is derived from tuffaceous volcanoclastic rock. Other locations within the Telkwa valley and within the volcanic rocks of the Telkwa formation are also experiencing landslide movement and sagging slopes (Schwab and Kirk 2003).

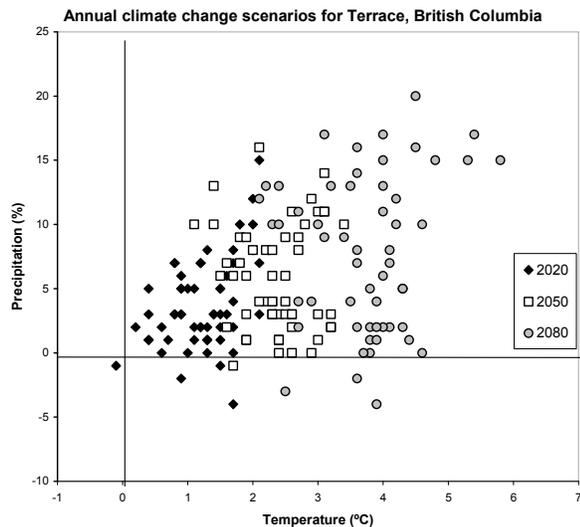
Figure 6. Annual climate change scenarios for 2020, 2050, and 2080 for Terrace, BC, with respect to a 1961-1990 global climate model baseline. The points represent the results of 58 different global circulation models, generally predicting a progressively warmer and wetter climate for Terrace. The data was obtained from the Canadian Institute for Climate Studies web site (<http://www.cics.uvic.ca>), and is modified from Geertsema *et al.* (2006b).

The Mink Creek flowslide near Terrace occurred after nearly a decade of increasing temperature and precipitation. Geertsema and Schwab (1997) provide evidence for an increase in flowsliding 2000 to 3000 years ago in the Terrace area under wetter climatic conditions. Almost all global circulation models predict warmer and wetter conditions in the future for the Terrace area (Figure 6), thus more such landslides may be expected in this area.
