CHARACTERIZING COMPLEX DEEP SEATED LANDSLIDE DEFORMATION USING CORNER REFLECTOR INSAR (CR-INSAR): LITTLE SMOKY LANDSLIDE, ALBERTA

Corey R. Froese

Alberta Geological Survey, Edmonton, Alberta, Canada, corey.froese@ercb.ca

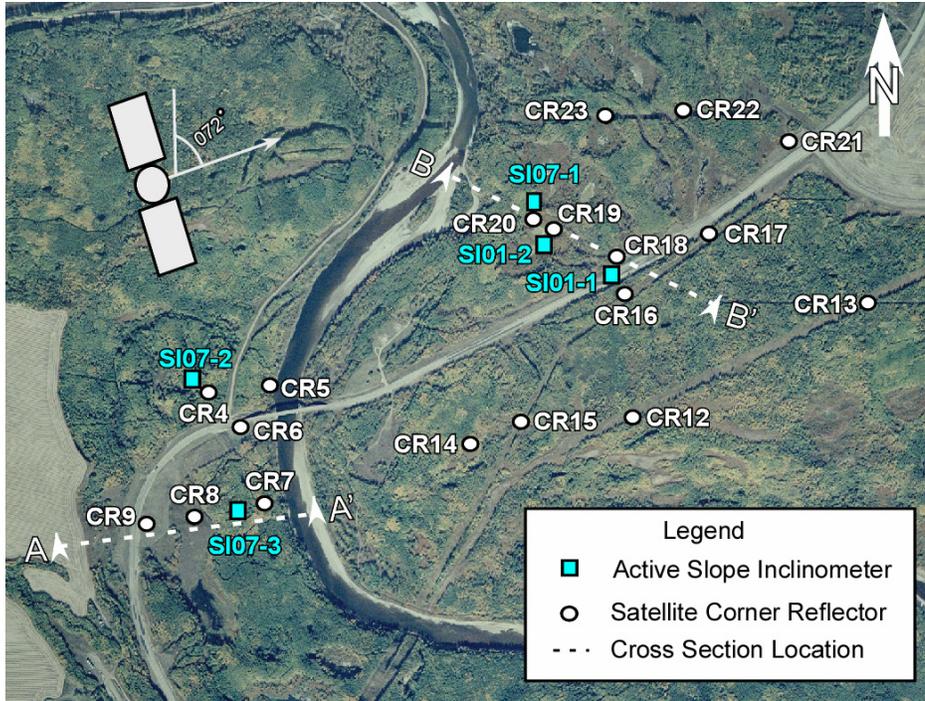
To improve the signal return to the spaceborne SAR sensor, eighteen small areas were cleared of vegetation and corner reflectors were installed (Figure 2). The reflectors are trihedral shaped and made of perforated aluminum (Figure 3). The trihedral design ensures that the radar signal is returned exactly in the incident direction and with the same polarity. The perforations are made to minimize the reflector resistance to the wind and to drain water accumulation. As long as the diameter of the perforations is much smaller than the radar wavelength, the radar signal will not be affected by the loss of reflective surface.

Figure 2. Layout of the corner reflector array in relation to recently installed instrumentation and profile locations.

As shown on the plan (Figure 2) the ascending F2N Radarsat-1 data was collected with a line-of-sight bearing of 072 degrees and a vertical angle of 50 degrees above horizontal (Figures 5 and 6). Therefore all of the CR-InSAR results show the component of the deformations at each reflector that occur along that bearing and dip angle. Under ideal situations where the line of sight and incidence angle are parallel to the direction of the slope movement, velocities close to real three dimensional slope movement velocities may be measured. Conversely on reflectors where the largest components of the deformation are near perpendicular to the satellite LOS or incidence angle, there is the possibility that no deformations may be detected in areas where significant movement may in fact be occurring. Both phenomenon are observed in the complex, rotational movements observed on the valley walls of the Little Smoky River and are discussed in the following section.

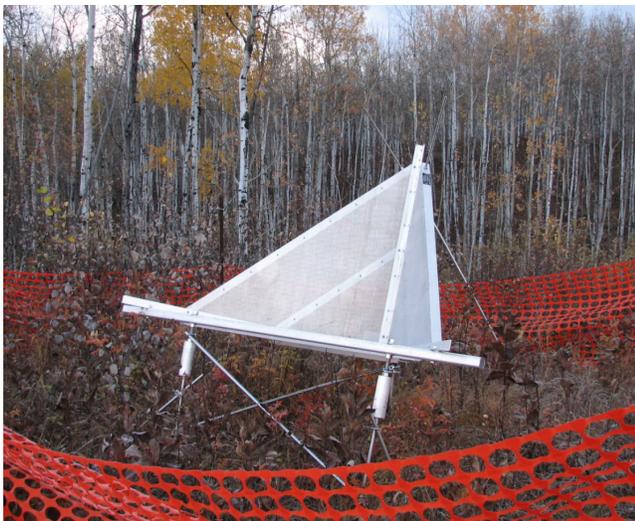
Figure 3. Photo of a corner reflector installed at the Little Smoky site

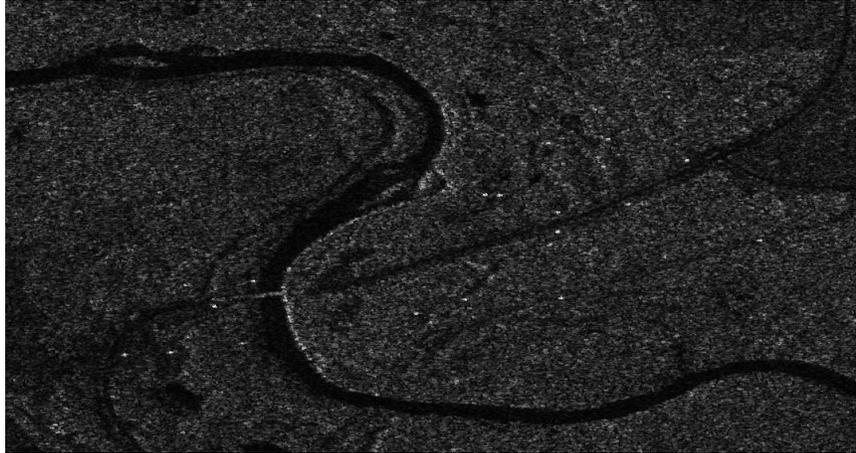
The acquired Radarsat-1 data confirms the proper installation of the corner reflectors. The reflectors can be easily identified on summer scenes where the abundant vegetation scatters the radar signal in all directions and the scenes are "darker", except the corner reflectors. The reflectors are harder to identify in the winter scenes where the snow or the bare Earth are strong signal reflectors. Some of the reflectors installed on slopes oriented along the radar line of sight are still visible because the radar signal is reflected away by the slope, but corner reflectors installed on slopes perpendicular to the radar line of sight are buried into clutter noise because the radar signal is reflected by the slope back to the radar receiver. Figure 4 provides a radar image showing the relative strength of the returns from the reflectors against the natural surface.

Figure 4. Radarsat-1 SAR image showing the location of the corner reflectors (white spots) in relation to the surroundings. Higher data quality is indicated by higher reflectance.

Since the 1970's, the majority of investigation has been focussed on areas of the highway that have been most significantly impacted upon by the landslides. In particular, the area in the proximity of SI07-2 and CR18 on Figure 3, there have been numerous investigations focussed around a very active headscarp that leads to annual maintenance (adding asphalt) of the highway surface.

Northeast Side: On the northeast side of the valley, reflector CR20 (Figure 3) was chosen to illustrate the

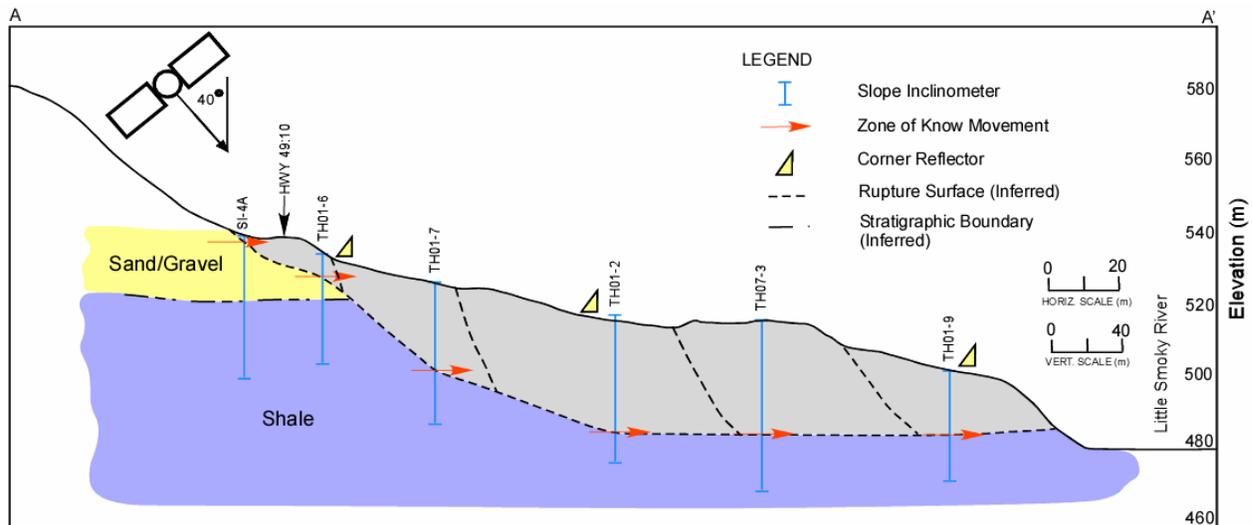
The geology and associated slope movement mechanisms on the southwest side of the valley are less complex than those on the northeast side of the crossing. The road and bridge on the south side are impacted by two adjoining slide zones; one on either side of the bridge. Borehole logs along profile A-A' (Figure 5) encountered clay and clay till derived colluvium overlying shale. The shale surface is approximately concave, dipping from a high point at about elevation 525 m and bottoming out at about elevation 485 m (about river level). The upper part of the valley is relatively steep, indicative of the thick upland till strata that is outside of the influence of the bedrock slide plane. Based on historical deformation data, previous geotechnical interpretations (Thomson and Haley, 1975; Bala and Proudfoot, 2007) and the slope morphology,

the landslide at Profile A-A' would be described as a rotational retrogressive earth slide in the colluvium that comprises the landslide mass. Available deformation monitoring data (Thurber 2007b) for the past year indicates that movement rates of up to 26 mm/year have been observed on the lower rupture surface for installed slope inclinometers (SI07-3) at this section.

Figure 5. Profile A-A' shown on Figure 3.

The north valley slope movement is significantly larger in size than the south side. Please note the 4x exaggeration of the horizontal scale between Figure 5 and 6. A broad

Southwest Side: Reflector CR7 is located along Profile A-A' (Figure 5) on the southeast side of the bridge crossing. This reflector is situated on the lowermost block of a rotational retrogressive slide where deformations have been monitored since 2001.

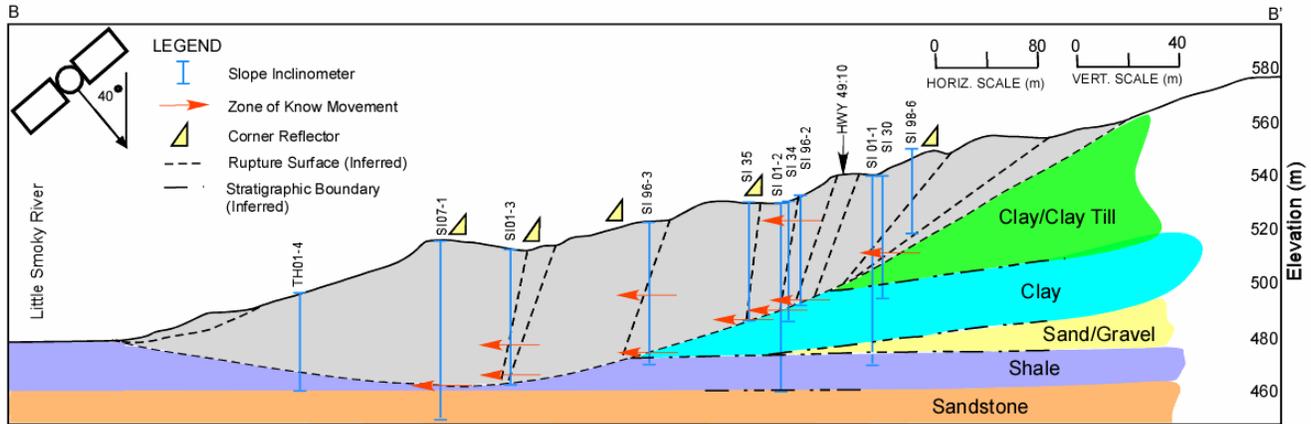
Figure 6. Profile B-B' shown on Figure 3.

Profile B-B' (Figure 6) provides cross-sectional representation of this area that shows the stratigraphy and movement zones identified over the past decade in investigations into this very active area of the northeast valley wall. As can be seen on profile B-B' the interpretation of deformation patterns and rate is complicated by the numerous blocks that comprise the slide and the fact that many of the previously installed slope inclinometers did not pierce the lower rupture surface, and therefore only provide information as to shear movement along the backscarp.

The true basal slide plane below the north valley slope remained elusive until a series of very deep slope indicators were installed in 2001 (refer to Figure 6). The boreholes, installed to 65 m depth, found the basal sliding plane mainly between elevations 465 to 485 m, approximately coincidental with that found on the south valley slope. Prior slope indicators, installed to shallower depths, intercepted intermediate back scarps of the translational block movement, giving a perception of a shallower based valley slope movement.

challenges in applying CR-InSAR. As seen on profile B-B', both CR20 and SI 07-01 are located at the head of a large rotational block in the lower portion of the slope. Readings were taken on the slope inclinometer between May and October 2007 (Thurber, 2007a) of up to 19 mm (47mm/year). The results obtained from the CR-InSAR analysis of target CR20 during this time period indicated negligible deformations (Figure 8). The reason for this is likely the opposite of what was discussed for CR7 on the southwest side of the crossing. As it is expected that the large block on which CR20 is located is moving in a rotational manner, it would be expected that there is a downward vertical component to the movement. If this component was significant enough, CR20 would then be moving nearly perpendicular to the line-of-sight of the satellite and deformations would not be quantified using CR-InSAR. A review of these trends in relation to the other reflectors on the northeast side of the valley is currently underway.

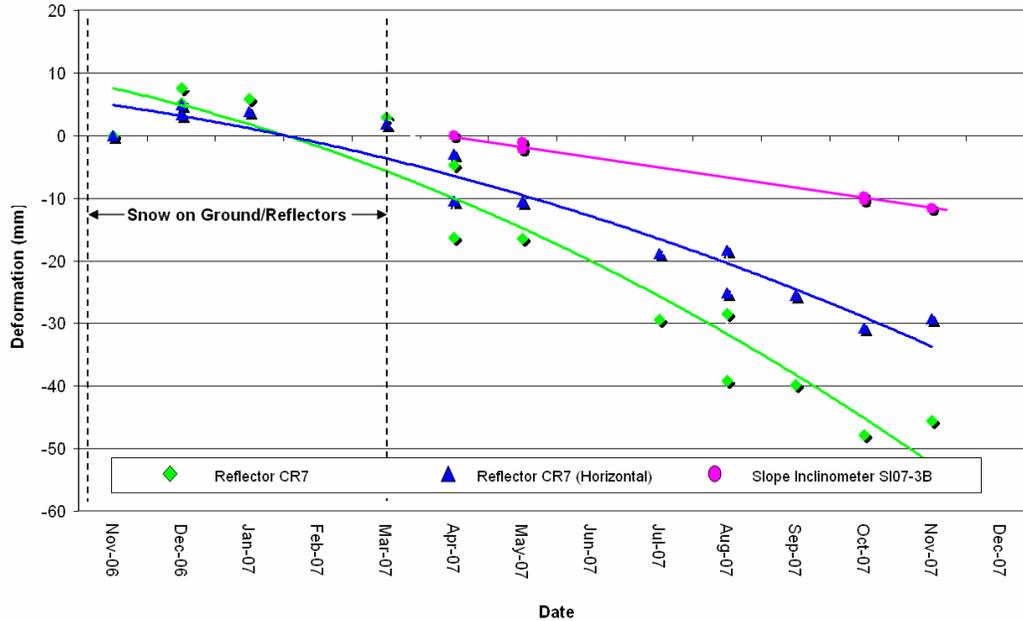
Figure 7. Deformations for CR7 vs. SI 07-3B (November 2006 to November 2007)

The information derived from the 2001 slope inclinometer indicates that the resultant vector (horizontal component) is nearly parallel to the line-of-sight bearing from the Radarsat-1 F2N and therefore ideal for measuring slope deformations. In order to characterize the measured movement, the CR-InSAR results obtained between November 2006 and November 2007 were compared to a newly installed slope inclinometer (SI07-3B) where total movements between May 2007 and October 2007 over 7.8 mm (extrapolated to 22.3 mm/year) (Thurber, 2007b) have been recorded (Figure 7). Deformations of up to 50 mm have been obtained on CR7. There are two likely contributions to this discrepancy. First, as reflector CR-7 is located on the lowermost rotational block and is likely moving at a faster rate than the upslope block on through which SI 07-3B is drilled. For the inclinometer that was installed on the lower block in 2001, overall deformation rates of up to 50 mm/year were observed prior to the casing shearing off.

Another likely source of the difference is the fact that the line-of-sight for the satellite is likely more directly in line with the actual deformation vector for the lower rotational block. As the block is likely moving in a rotational manner, there would be expected to be a vertical component to the deformation that would not be detected on the slope inclinometer as it only projects the horizontal component of the deformation. Figure 7 also shows the results obtained from the CR-InSAR projected into the horizontal component to show the overall deformation of approximately 30 mm.

Using data from a local meteorological station, the snow accumulation on the ground was charted against all of the deformation profiles and a clear correlation was observed. Therefore, it is assumed that the periods when there is snow on the reflectors the results are not reliable; these periods can be clearly identified on Figures 7 and 8 .

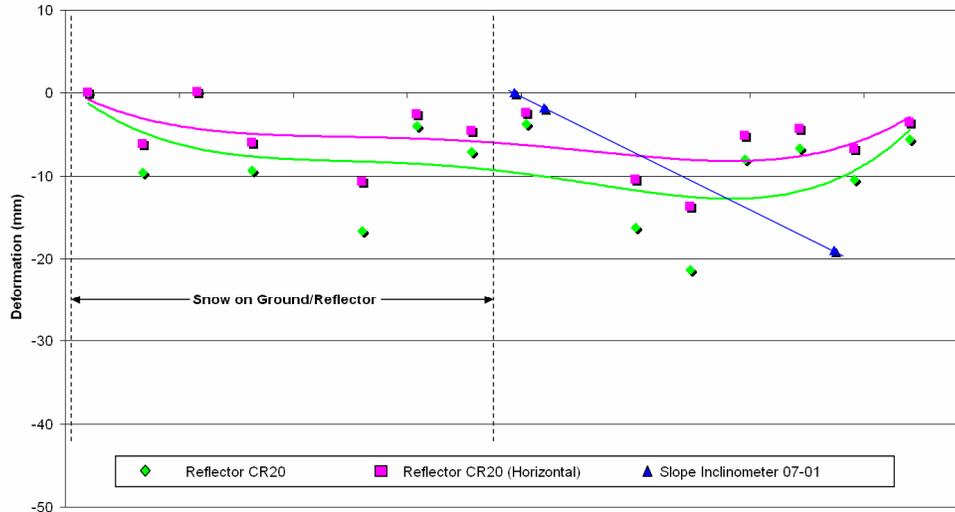
Figure 8. Deformations for CR20 vs. SI 07-1 (November 2006 to November 2007)
